**UNITED STATES DISTRICT COURT  
SOUTHERN DISTRICT OF FLORIDA  
MIAMI DIVISION**

CASE NO. 1:20-cv-24294-KMM

**EXPERT REPORT OF DR. RODOLFO GUILLERMO PREGLIASCO**

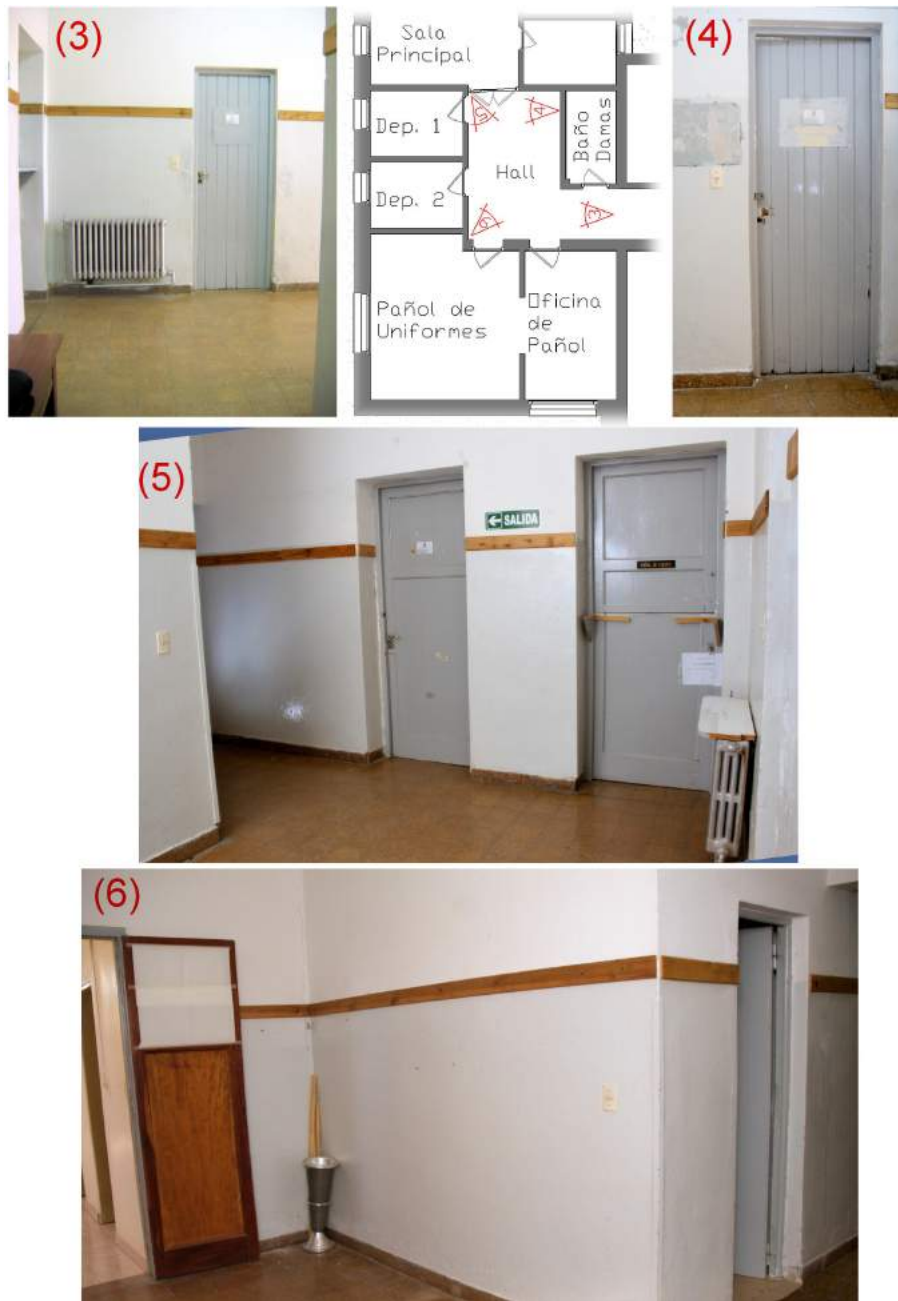
Figure 5 Photos of the main building. Hall of the west wing.

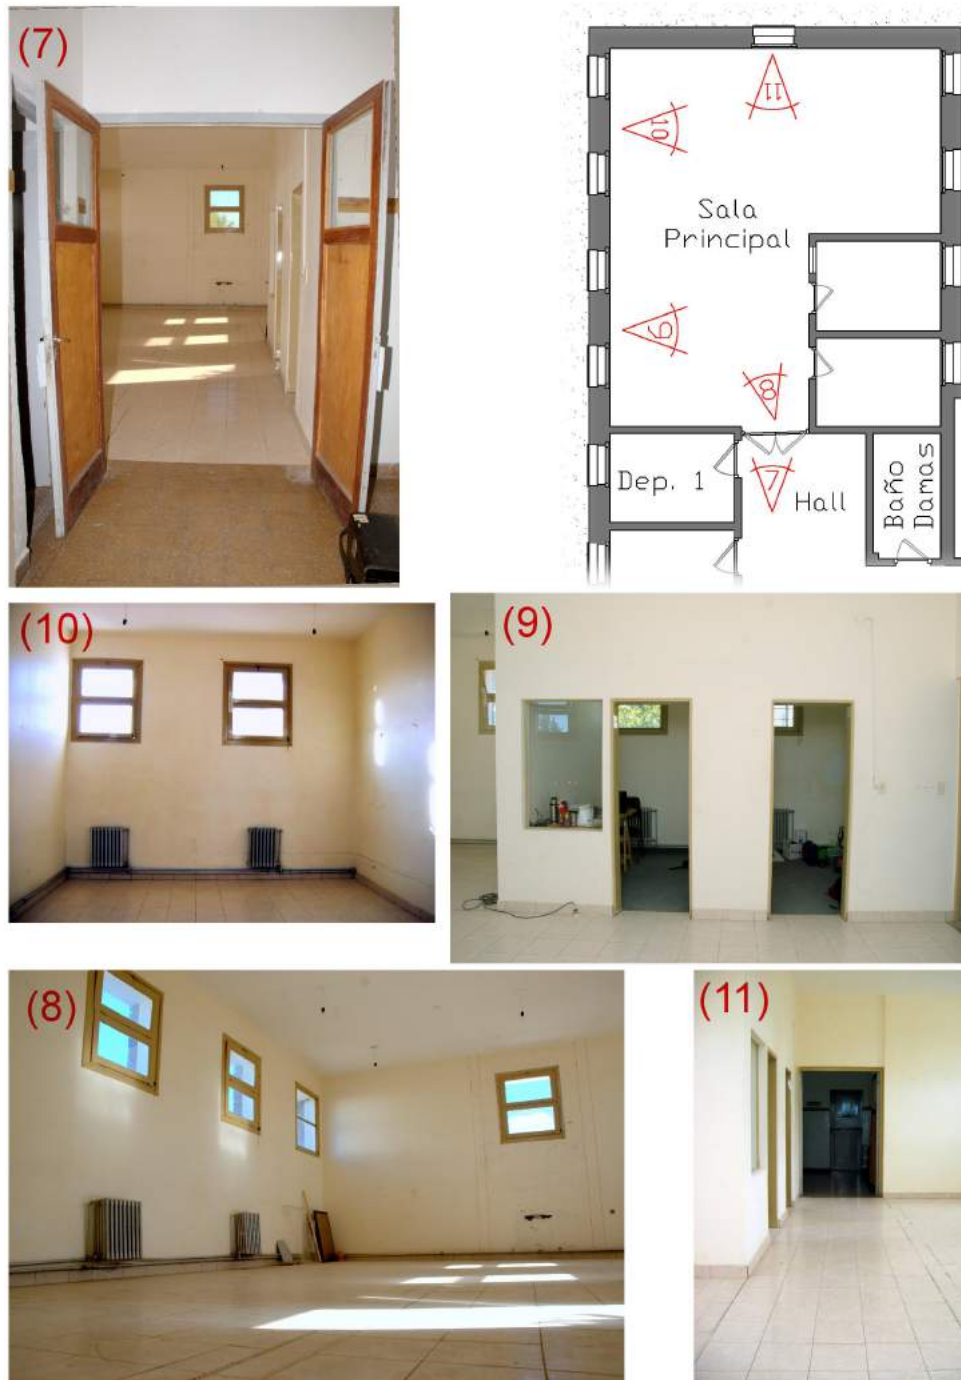
Figure 6 Photos of the main building. West wing.

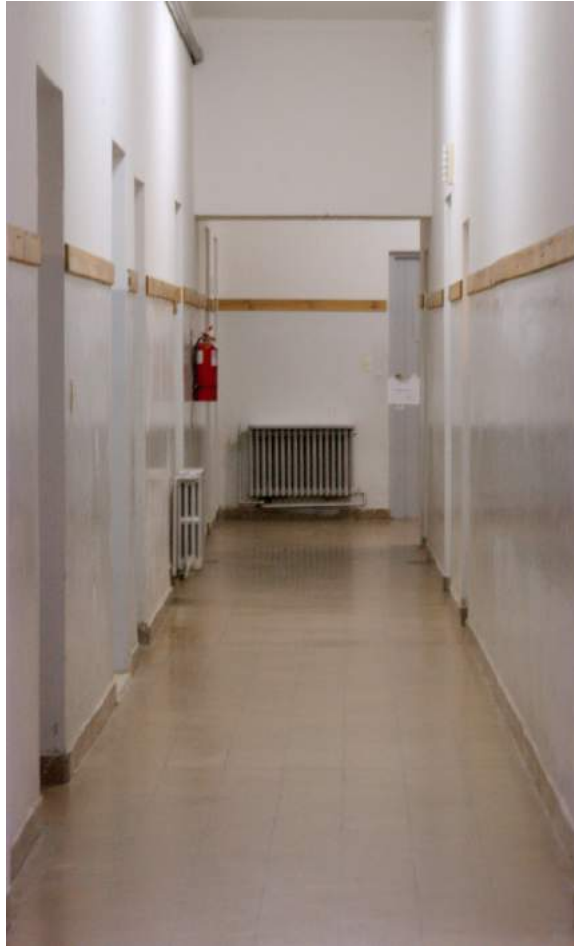
**Figure 8** Entrance hallway to the west wing. Photo taken from the entrance hall, in the direction of the main room. The wood trim that conceals the difference between the paints below and above 1.70 meters from the floor is visible.

29. We identified a differentiation of the history of the paint layers based on height. The history of the paint layers below 1.70 meters (slightly under 5 ft. 7 inches) is different than that of the walls above 1.70 meters. In figure 8 we show a view of the hallway of the west wing, taken from the entrance hall, facing the cells. At 1.70 meters from the floor, there is a piece of wood that conceals the change in paints. It appears that, because the area below 1.70 meters requires

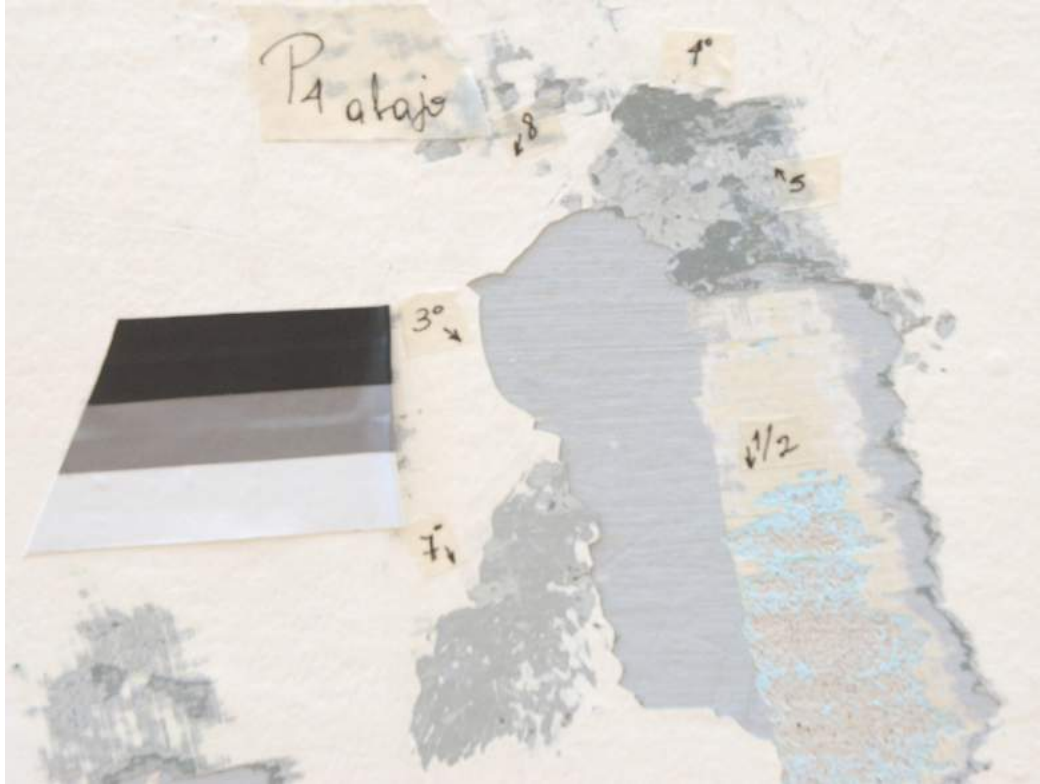
**Figure 10** One of the pictures used to measure color. Note how disorderly successive colors appear. On the left is the reference of white, black, and gray tapes.

Measuring each color implies taking some pictures and including a reference pattern. We used three strips of insulating tape: white, black, and gray. With this simple method, we created a comparative colometry of the paints (Fig. 10).

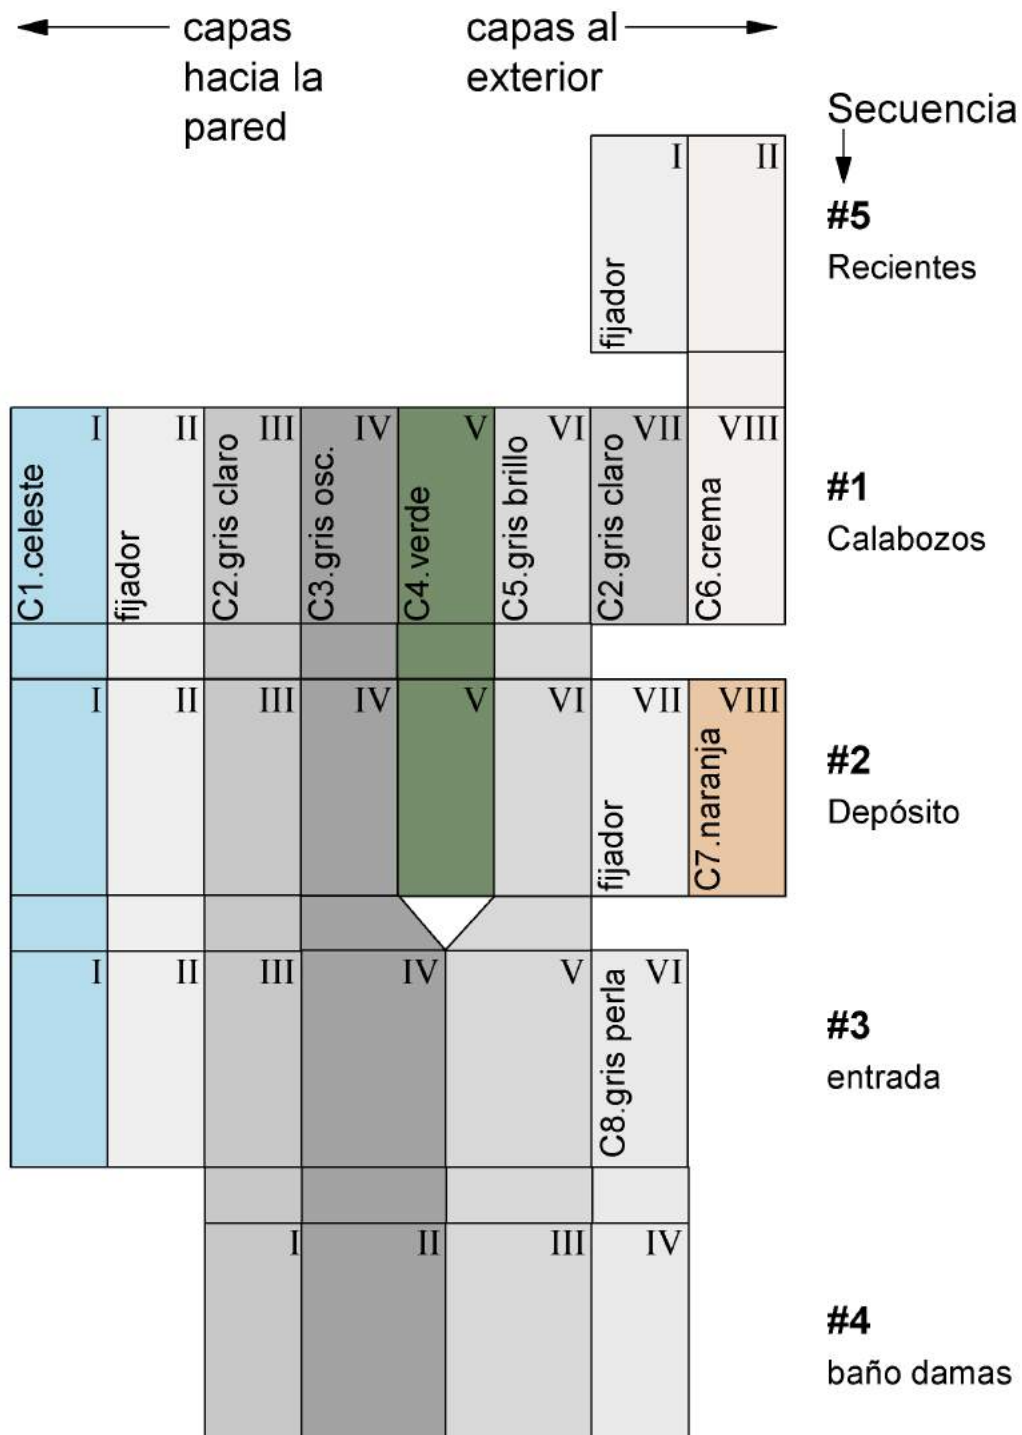
**Figure 12** Paint sequences identified. Each rectangle signals a layer of paint. We aligned and joined paint layers of the same color. The colors of the graphic are approximate and indicated with the nomenclature C1...C8. Layers are numbered with Roman numbers that increase from the wall to the exterior. Translation note: "capas hacia la pared"=layers toward the wall; "capas al exterior"=layers toward the outside; "Secuencia"=sequence; "Calabozos"=cells; "Depósito"=storage room; "Baño damas"=ladies' room.

33. A careful observation of the sequence of paints (fig 12), shows that there are three sequences that are very similar: Sequence #1 (cells), Sequence #2 (storage room 1) and Sequence #3 (entrance). The three of them share the first three layers of paint. The green layer (color C5), only found in what was used as prison cell, is very thin and strongly adhered to the outer adjacent layer (layer VI). It is very likely a base aggregated to fix paint C6. If so, the three sequences describe a common history up to layer VI in Sequences #1 and #2 and up to layer V with sequence #3. Starting with this layer, the three areas were painted once or twice, but each with different paint colors.

We can therefore affirm that **when the building was first opened, it was painted in light gray (color C2 in figure 12) and that the first three layers of the *main sequence* were applied to everything.** Every structure or wall that shares these three first layers of the original sequence very likely was part of the original structure of the building. However, if there are additional layers that a structure or wall shares with the original sequence, the presumption of a common origin can be completely confirmed. When a reform (remodel or repair) is done, it will be painted in the same color as the rest of the walls as they are at the time of the reform. At that moment, however, the contractors or painters would only be interested in matching the external (visible) paint color of the wall, not the underlying layers of paint from prior paint jobs.

52. Although the walls of the main hall have the paint layers of the original sequence, on the strips where the cell partition walls were, we find Sequence #5 (figs 11 y 12). This sequence consists only of one layer of primer and one layer of cream white paint (C6). This means that **the partition walls of the main room were demolished when they were painted with layer VII of paint, which is a light gray color.** Very likely, as a result of this remodeling, the entire room was painted in the color that it currently has. This is the most recent reform (remodeling or repair) that I can identify.

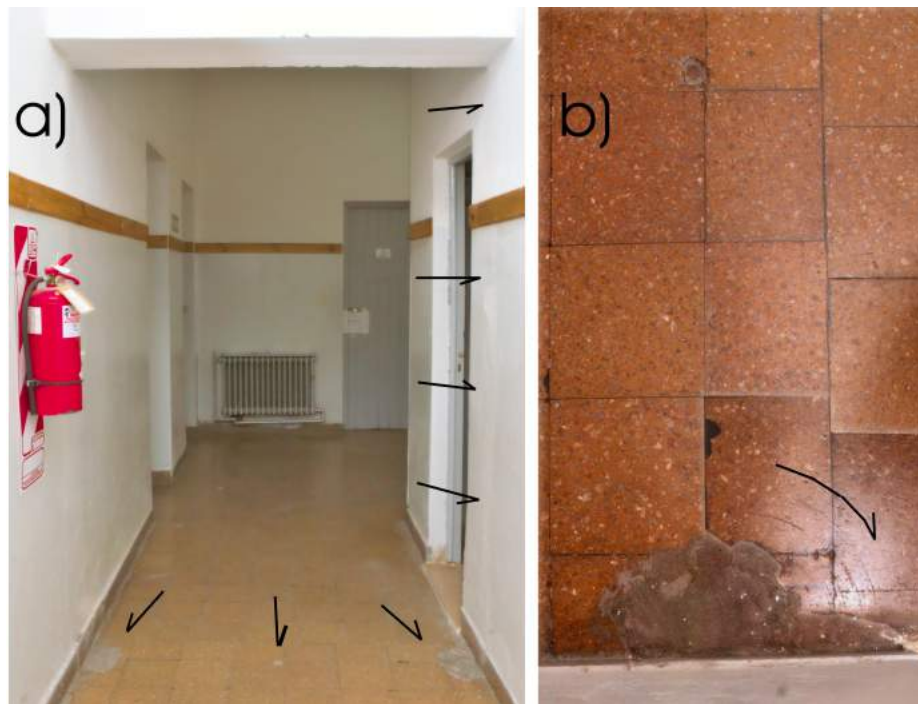
**Figure 13** Evidence of the now-removed entrance door in the west wing. (a) View from the entrance hallway that led to the cells. The three marks on the floor can be seen, as well as the irregular wall on the vertical line of the marks. (b) Floor detail on the side of the current ladies' bathroom, showing prints left by a moving door rubbing against the tiles.

38. Next to the door of the current ladies' bathroom, it is very clear, because of the markings on the tiles, that once there was a couple-leaf access door (Fig.13(a)). Repair markings are visible at the spot where the frame of the door was embedded into the floor and the walls.

At the center of the hallways, a hole in floor is visible, where the lock of the door leaf that does not have the handle used to fit. The hole is approximately 1.5 cm off-center, towards the south of the building. This indicates that that handle was on the north side, that is, on the side where the current ladies' room is located.

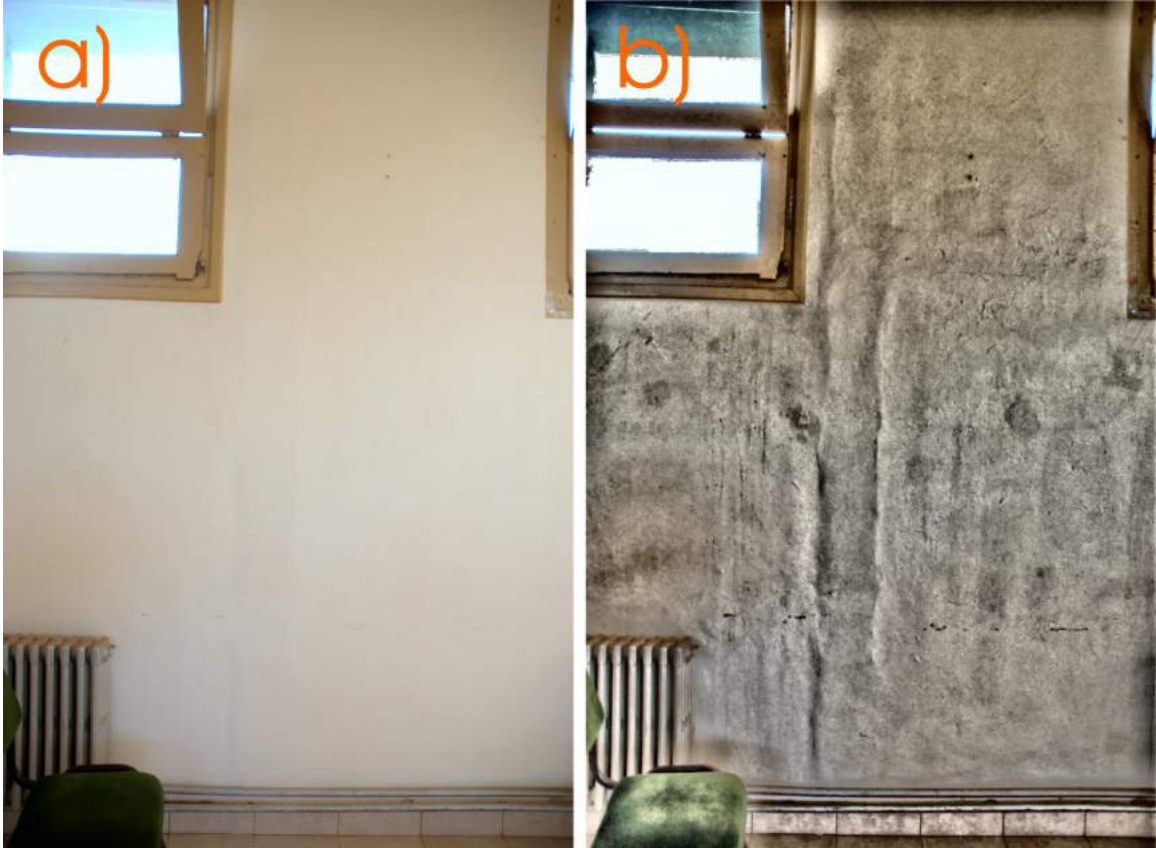
**Figure 15** (a) Picture of the west wall in the main room. (b) The same picture after applying a highlight of local contrast. Note how the position of the wall becomes visible, as well as other repairs, imperfections, and small damages that passed unnoticed in the original picture.

Figure 15 shows the effect of the local contrast operation. In this way, the site of the walls that were there, but have been removed, become visible.

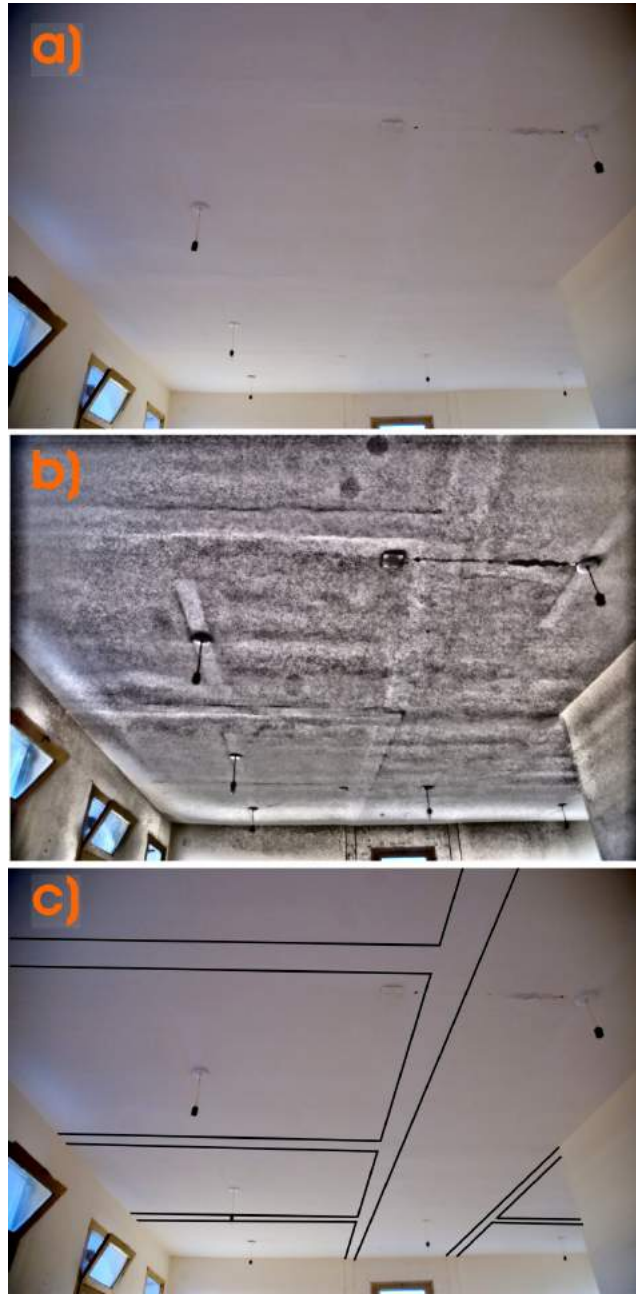
**Figure 16** (a)Photo of the ceiling of the main room, facing the northern side. (b) The same picture, with local contrast highlights. The original position of the walls can be seen, as well as lamps hanging from electrical boxes, and marks left by tube fixtures. (c) The original picture, plus the ceiling lines that were observed though contrast imaging in picture (b).

47. The ceiling is the most descriptive place, because it is practically a map of what was originally in place. Figure 16 shows where the walls of the cells were located.

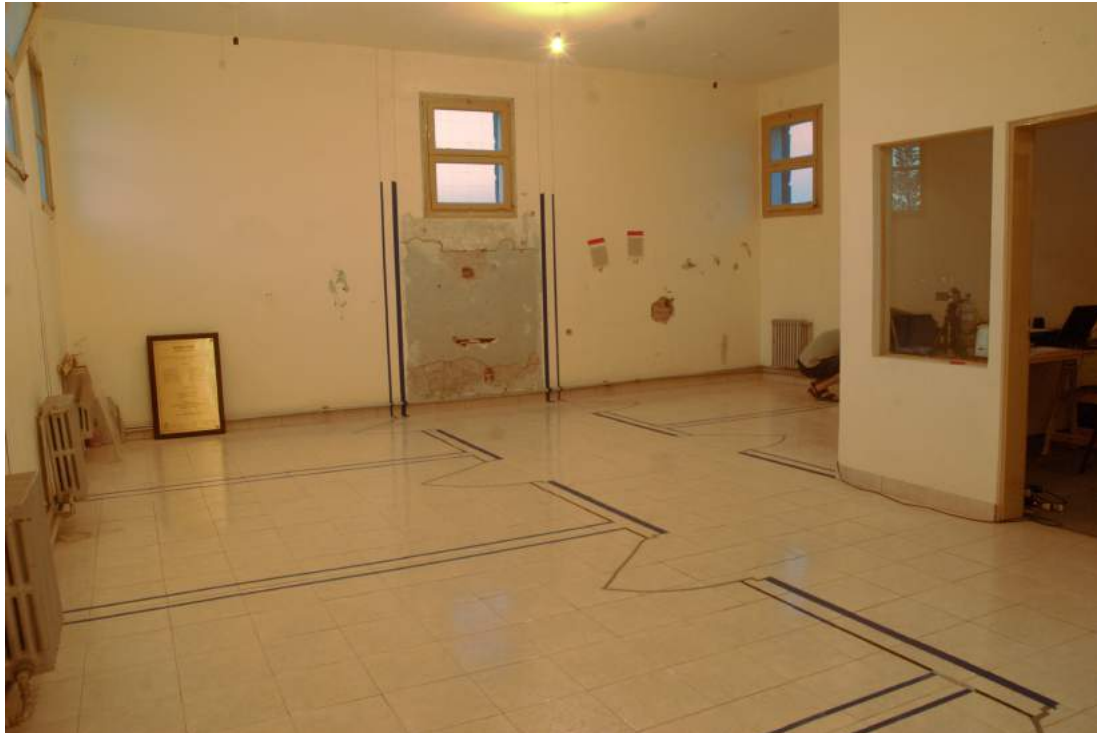
**Figure 18** Reconstruction of the walls that took place on-site. This is the step prior to the drafting of the floor plan.

55. Considering the elements presented in the paint analysis, the floor markings, the relief on the walls and ceiling and the compatibility of our findings with the testimonies I reviewed, I reconstructed the layout of the west wing of the main building by drawing directly on the floor of the space. see figure 18.

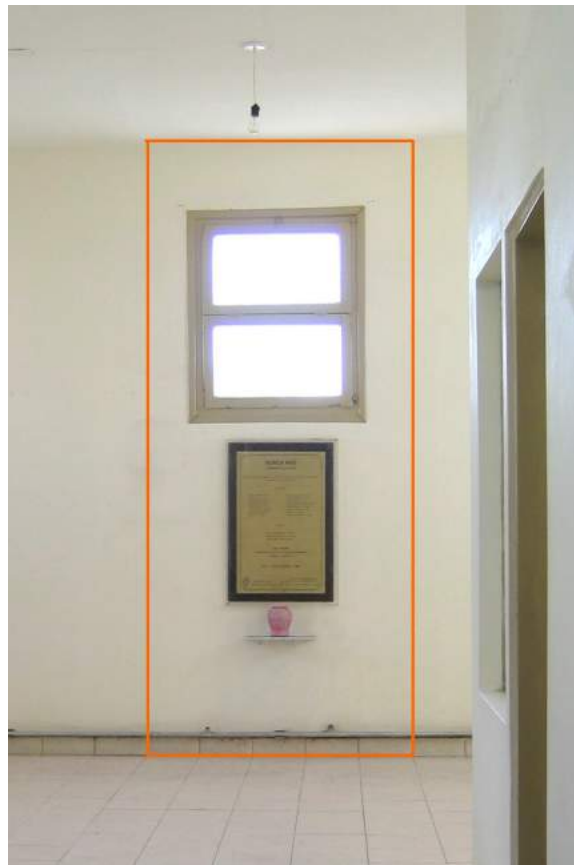
**Figure 19** Wall of the end of the hallway in the state in which it was at the beginning of the work I conducted with my team. The orange rectangle is the area of analysis.

the north wall in the west wing that is 1.5 m wide by 3.50 m tall. Because the cells are no longer in place it is now a section at the center of the larger north wall of the main room of the west wing (Fig. 19). Figure 20 shows a complete view of the wall in question and its main dimensions. When the cells existed, as seen in figure 19, and figure 7, above, this was the only portion of the north wall that was visible from outside the cells of the west wing.

- (b) **below the black horizontal line** the wall mortar was removed all the way to the brick wall and replaced, such that no vestiges of shots remain. However, this allows the conclusion that **any and all gunshots that reached the wall must have hit the region below the 1.70 m mark.**

- (c) **While we do not find evidence of traces of gunshots, it is plausible that this wall received gunshots and was repaired by removing all the mortar, down to the bare wall. The irregular line of repair suggests, at least, that the repairs were guided by the kind of damage that would be consistent with a spray of bullets.**

88. No traces of bullets were found in the north wall below 1.70 m. However, this area of the far north wall was subjected to a dramatic form of repair, where the area of the wall was chipped all the way to the brick, combined with the irregular shape of this extreme repair suggests that the wall may have contained evidence of shots that would be consistent with the shooting of prisoners by aiming at their bodies and shooting them with PAM sub-machine guns. We concluded,

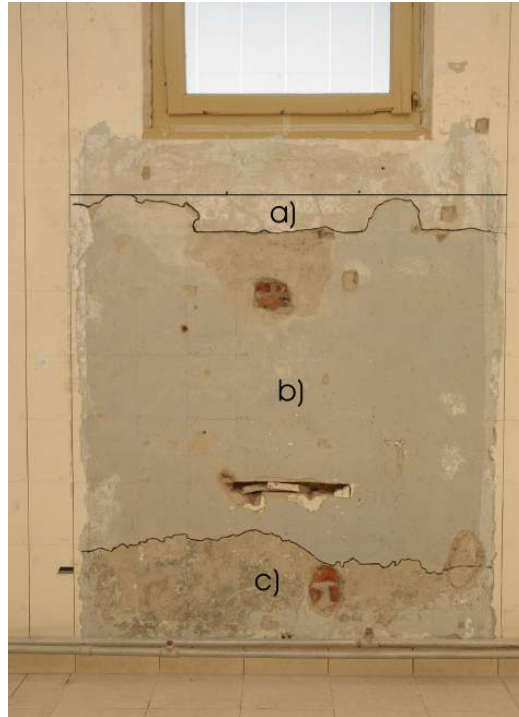
**Figure 22** Paint layers found in distinct areas of the far north wall. Beyond the 1.70-m line, the sequence is the same as that on the upper part of the rest of the main hall. Zones with different paint layer sequences in the far north wall: (a)Upper area: between the horizontal line at 1.70 m from the floor and a lower irregular limit marked in black. The wall kept remnants of primer. (b)Intermediate area: between two irregular borders. The wall was painted in light gray. (c)Lower area: from the bottom edge of the intermediate zone to the floor. The wall was painted in dark gray. Above the 1.70 m line the sequence of paint layers also changes.

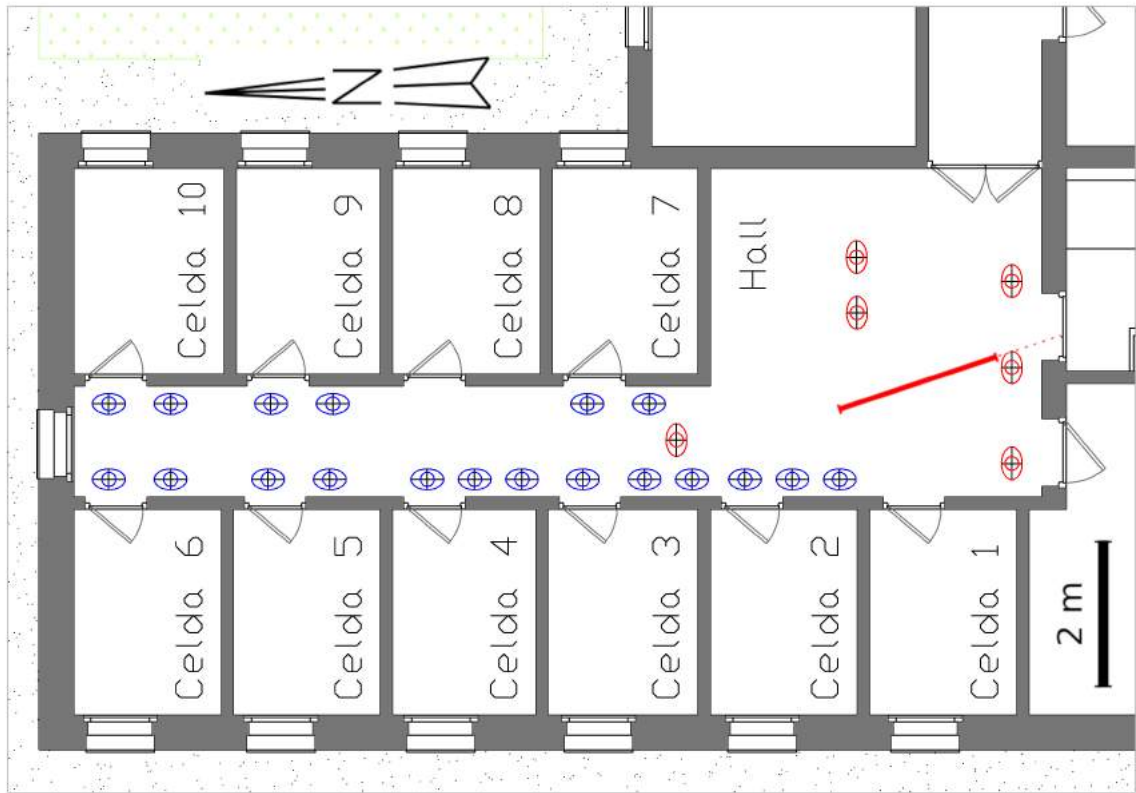
**Figure 25** Representation of the layout as described in Bravo’s declaration, but at the correct scale. We include as a red line the set of positions compatible with the shooting to the south direction impacting on the door.

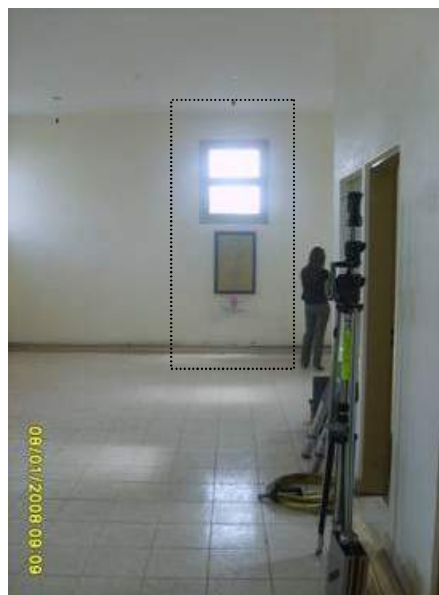
*Foto 1. Sector donde se realizaron las mediciones.*

En total se realizaron 95 gammagrafías de 43 x 35 cm, de las cuales 90 se hicieron sobre el sector de pared correspondiente a lo que en 1972 era el fondo del pasillo del sector de calabozos, hoy área denominada de "pañoles y habitabilidad" que se muestra en la Foto 1, cubriendo una superficie de aproximadamente 4 m<sup>2</sup>. Otras 4 placas se realizaron en el techo, en lugares próximos al mencionado sector de pared, y 1 placa se tomó sobre la pared mencionada a unos 2 m a la izquierda del eje del antiguo pasillo. En el sector donde se hizo esta última irradiación y previa a la misma, se introdujeron 3 balines de rifle de aire comprimido (calibre 5mm) en sendas perforaciones de 1, 5 y 9 cm de profundidad. El objeto de esta medición es contar con el registro de un elemento de plomo de dimensiones conocidas que sirva de referencia para la identificación de elementos del mismo material en el resto de las gammagrafías

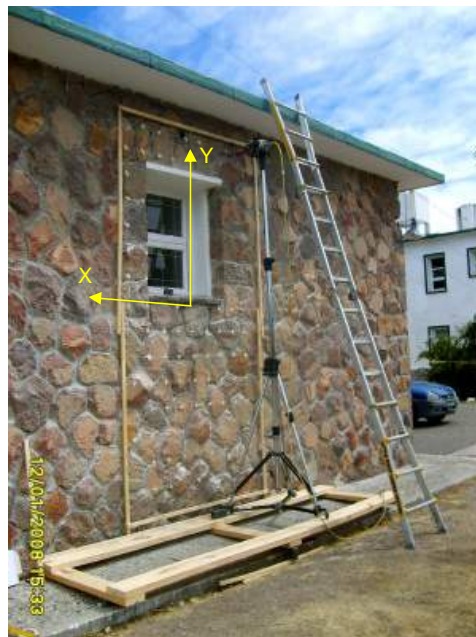
**Foto 2.** Bastidor y grilla en la pared exterior durante una medición en el sector superior. El riel de madera facilitó el desplazamiento del sistema fuente

Esta grilla se dibujó sobre la pared interior y luego se reprodujo sobre la pared exterior. En este caso la superficie de la piedra con que está revestida la pared del lado exterior obligó a construir un bastidor de madera y utilizar piolines para marcar los nodos (ver Foto 2).

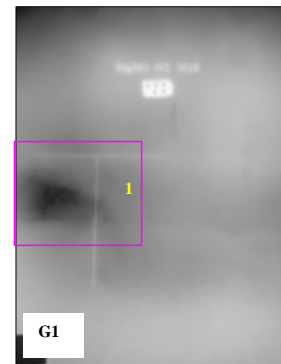
### Caso 1 (Gammagrafía 1)

En la posición (1, -2) [0,-6.5] se observa una figura circular de ~2 cm de diámetro delineada por un borde oscuro que se corresponde con un defecto en el revoque de la pared. Contigua a esta figura y hacia la izquierda de la misma se observa una zona oscura en forma cónica que podría corresponder a la proyección de un agujero, o agujero relleno con material de menor densidad, casi-perpendicular a la superficie de la pared.

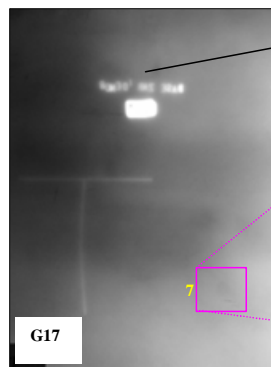
Agujero en la pared donde se alojaba tarugo para tornillos

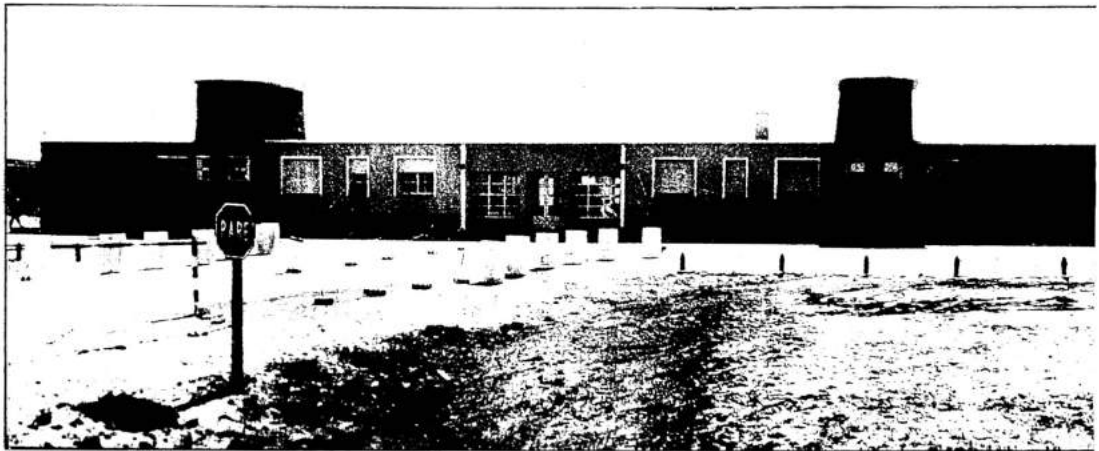
Base Aeronaval Almirante Zar, ubicada a un kilómetro del Aeropuerto Civil de Trelew. La foto corresponde al frente del edificio de la guardia, donde ocurrió el sangriento suceso.

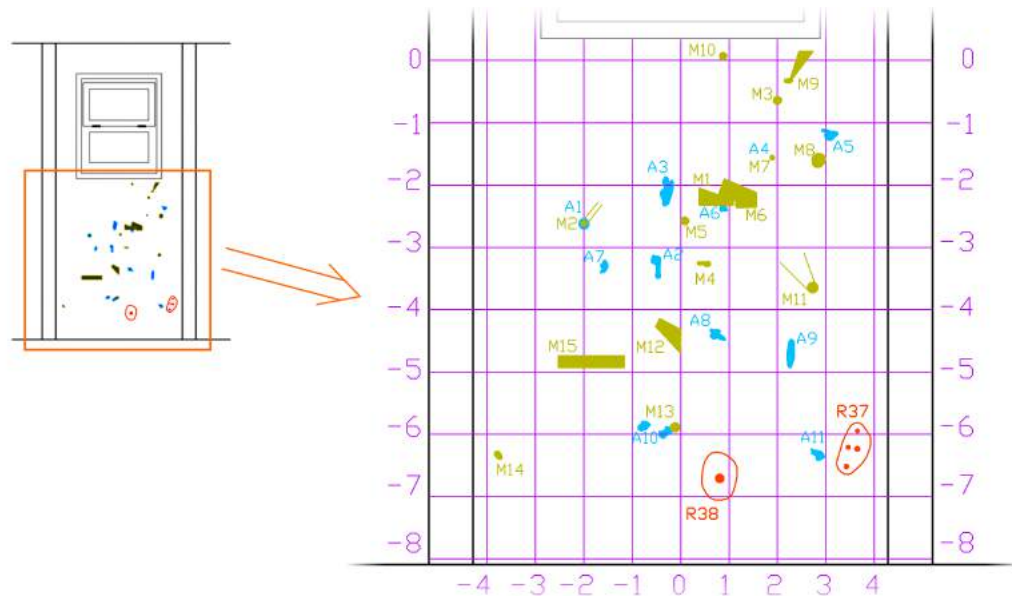
**Figure 27** Regions of the far north wall where the structure of the mortar was studied. The zones marked with the letter **M** are the anomalies in the gamma ray images; those marked with the letter **A** are the zones that were studied in further detail.

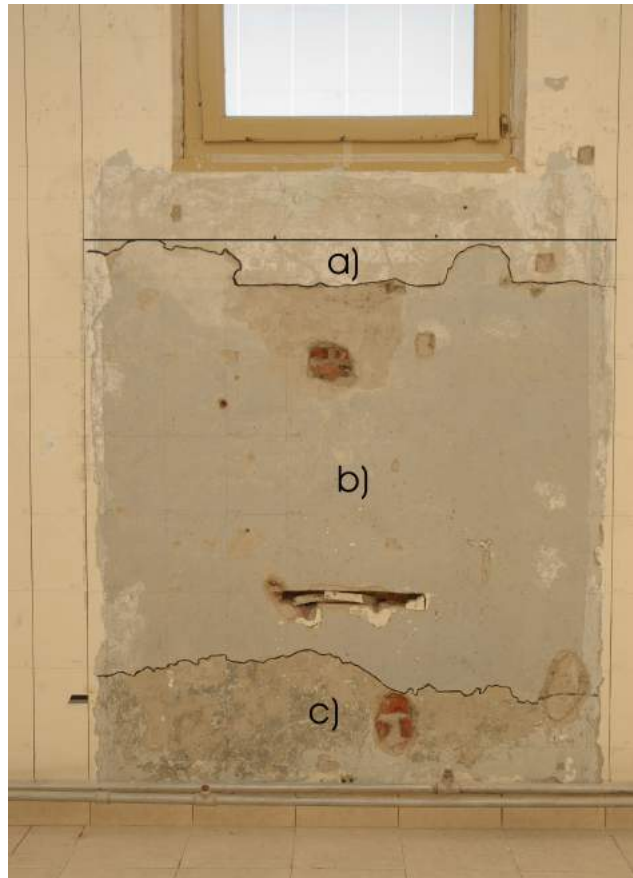
**Figure 29** Paint layers found in distinct areas of the far north wall. Beyond the 1.70-m line, the sequence is the same as that on the upper part of the rest of the main hall. Zones with different paint layer sequences in the far north wall: (a)Upper area: between the horizontal line at 1.70 m from the floor and a lower irregular limit marked in black. The wall kept remnants of primer. (b)Intermediate area: between two irregular borders. The wall was painted in light gray. (c)Lower area: from the bottom edge of the intermediate zone to the floor. The wall was painted in dark gray. Above the 1.70 m line the sequence of paint layers also changes.

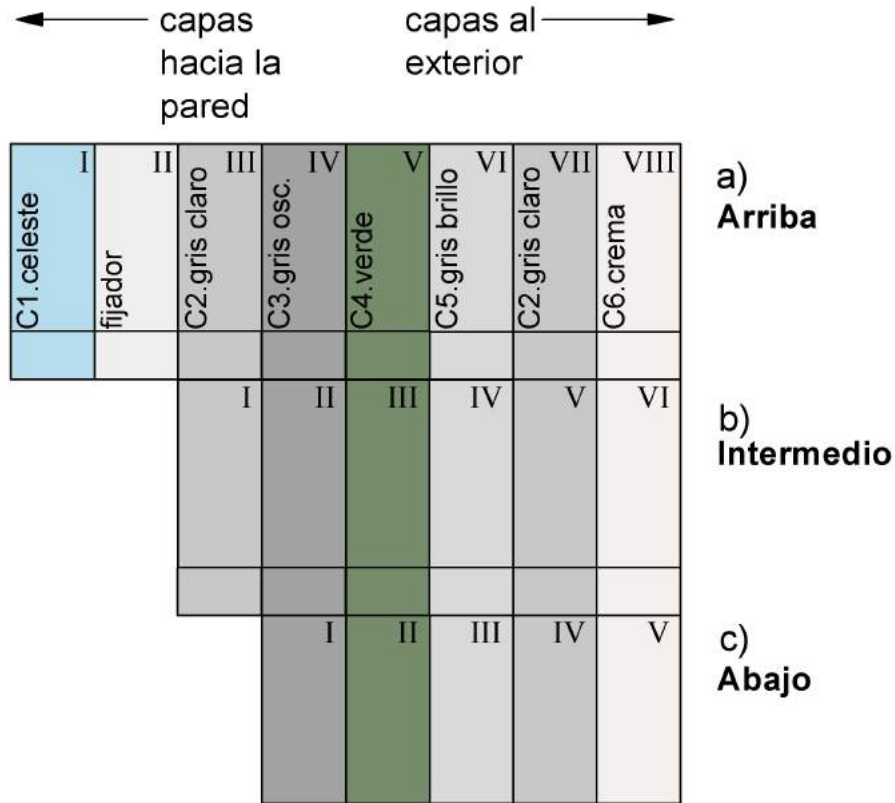
**Figure 30** Paint layers found in various zones of the far north wall. Beyond the 1.70 m line, the sequence is the same as that of the upper part of the rest of the cell block’s main area (which we refer to as the ”main room”)

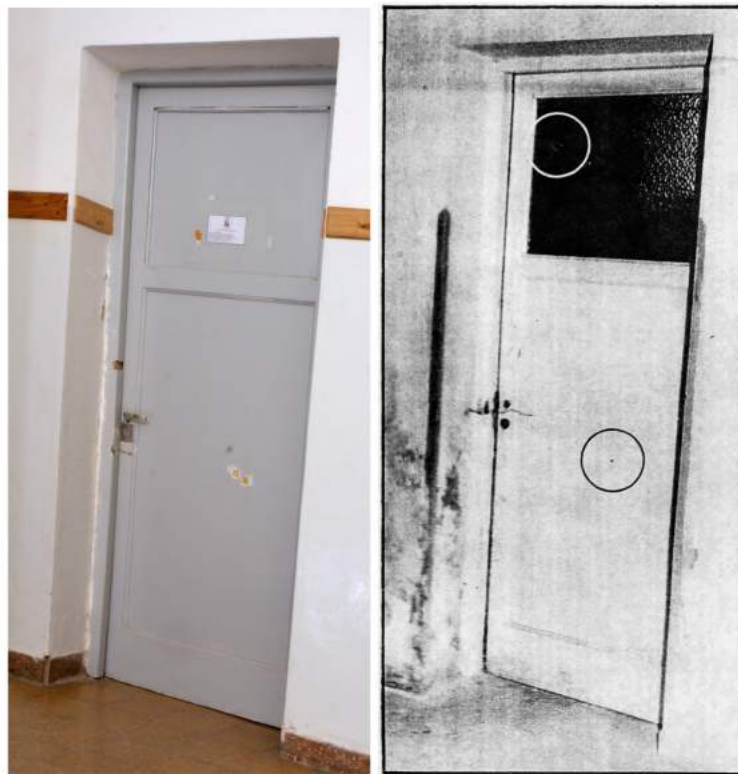
**Figure 34** Two pictures of the bathroom door: (left) the current one, and (right) in 1972.

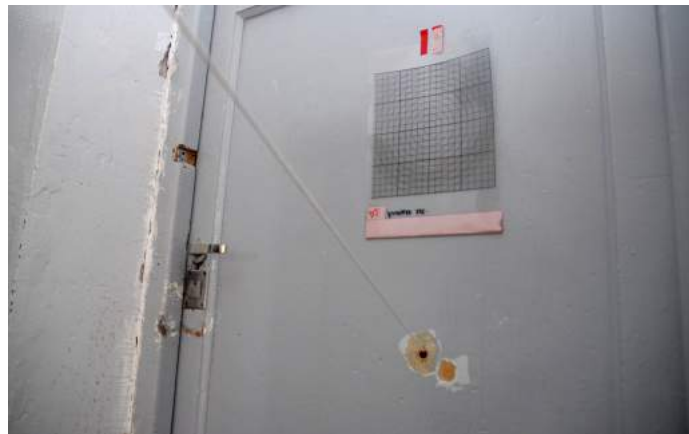
measured on the horizontal plane. We placed a string to indicate the central direction of the cone (figure 36).

**Figure 36** The uncovered orifice in the door. The string indicates the central direction of the cone of possible directions of the shot.

To measure this, we introduced an 11 mm-diameter rod into the hole. The rod can move inside the hole with certain limitations. We recorded the directions the rod can take and obtained a cone with its vertex in the orifice of the door and containing all shot directions compatible with the orifice of the door. Figure 35 shows the system of coordinates used and table 5 shows the results of the directions that define the cone of possible directions.
